## Marie Marland Reserve

## Introduction

This report is a Comprehensive Inspection Audit Report on the Marie Marland Playground located at the Marie Marland Reserve, Hudson Rd which is owned and maintained by the Town of Port Hedland. The audit was completed in accordance with the current Australian Standards for Playground Equipment. This document and its attachments are designed as part of a ‘Standard of Care’ to identify the current condition of the playground equipment and the surrounding environment. The purpose is to identify any non-conforming conditions in accordance to the current AS Standards:

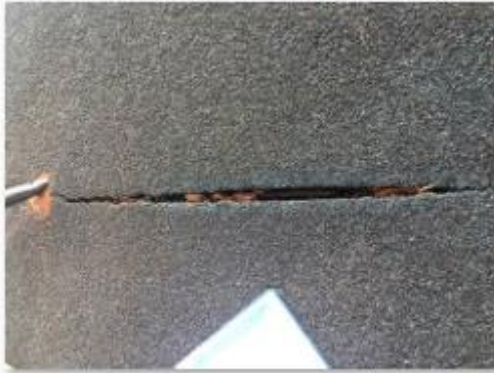
Audit Results						
Issue number	Description/Risk	Photo	Risk			Recommendation
			Likelihood	Consequence	Risk Level	
1)	Rubber soft-fall showing extensive signs of cracking and pulling away at joins. There are a lot of patches where it has been replaced.

Possible	Major	Medium	As per AS 4685.0:2017 the soft fall surface will need to be tested for Impact attenuation as the certification is unknown. There is no containment around the soft fall area.

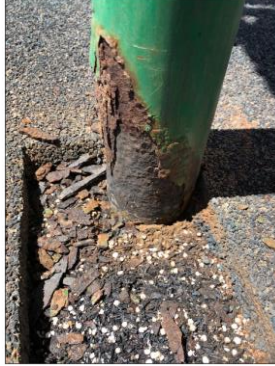
<p>2)</p>	<p>Protective paint and surface is rusting and chipping, coming away from the surfaces. This may affect structural integrity.</p>

<p>Possible</p>	<p>Major</p>	<p>High</p>	<p>The sections that are affected need sanding/acid wash and repainting to prolong life and reduce risk of rust.</p> <p>Where the structural integrity may be affected further investigation is required.</p>
<p>3)</p>	<p>The panel is showing signs of rusting.</p>

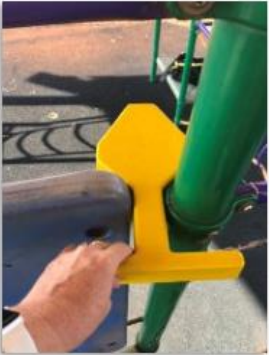
5)	<p>Entrapment (Partially bound openings) Waterfall climber has been removed and replaced with a panel which has created a potential head/neck entrapment.</p>

Possible	Major	High	<p>Order suitable replacement panel to attach. Regular maintenance is required under AS 4685.0:2017</p>

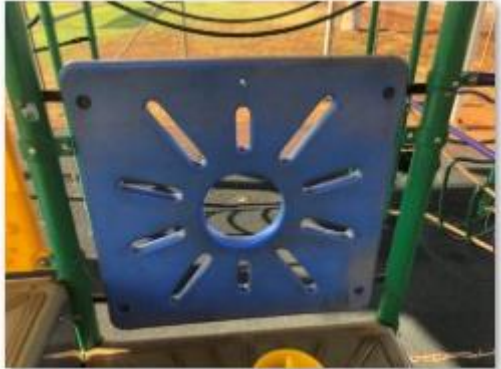
6)	<p>Unintended Access/increase in free height of fall. Waterfall climber was removed and replaced with a panel from a different supplier</p>

Possible	Major	High	<p>The panel is located above 1200mm, and allows unintended access that increases free height of fall. The softfall needs to be tested for this new height. The panel should be replaced with an item that will suit the requirements. Regular maintenance is required under AS 4685.0:2017</p>

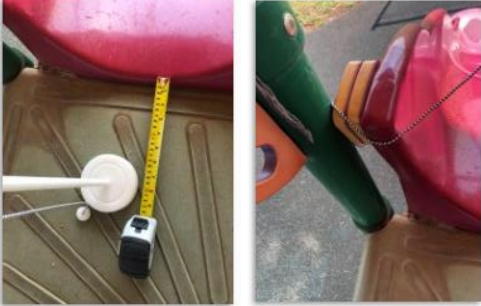
7)	Potential Entrapment (Clothing/toggles) on Left hand slide.

Possible	Minor	Medium	<p>Re-inspect with new toggle test device as the new AS only requires shorter toggle length of 400mm to confirm fail.</p> <p>Under AS 4685.1:2014 the toggle was obstructed and remained entrapped when the test device was moved in the direction of forced movement.</p>
8)	Entrapment (finger 8mm & 25mm) on panel above 1200mm

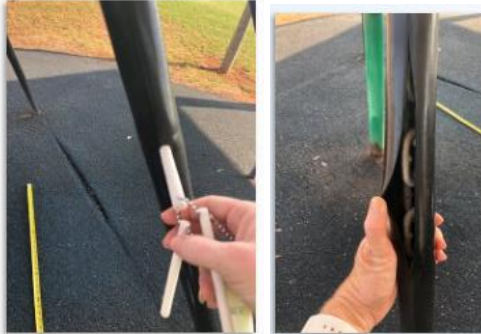
Possible	Minor	Low	<p>There is no forced movement in the area with finger entrapment, however as a duty of care the holes in the panel should be plugged to prevent entrapment.</p>
9)	Entrapment (fingers 8.6mm & 12mm) in the Crows nest where the plastic chain sleeve is cracked and exposing the chain above 1000mm

Possible	Minor	Medium	<p>Replace plastic sleeve over chain if possible.</p>

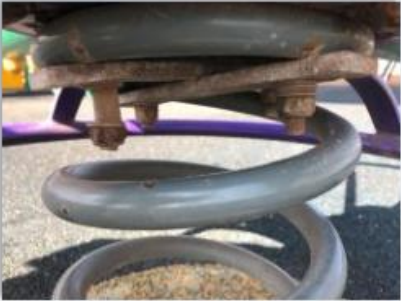
10)	Protruding parts

Possible	Minor	Medium	<p>Replace bolts with ones that do not allow protrusion in the next two weeks. Regular maintenance is required under AS 4685.0:2017</p>
11)	Equipment/components have been removed and not replaced.					<p>Seven items have been removed from the main structure and the crows nest climbing structure. This highly decreases the play value of the playground and will create issues with compliance. The manufacturer is no longer operating which makes replacing infrastructure difficult. Replacing components with alternative parts can cause potential hazards and/or risks to users.</p>
