## Marie Marland Reserve

## Introduction

This report is a Comprehensive Inspection Audit Report on the Marie Marland Playground located at the Marie Marland Reserve, Hudson Rd which is owned and maintained by the Town of Port Hedland. The audit was completed in accordance with the current Australian Standards for Playground Equipment. This document and its attachments are designed as part of a ‘Standard of Care’ to identify the current condition of the playground equipment and the surrounding environment. The purpose is to identify any non-conforming conditions in accordance to the current AS Standards:

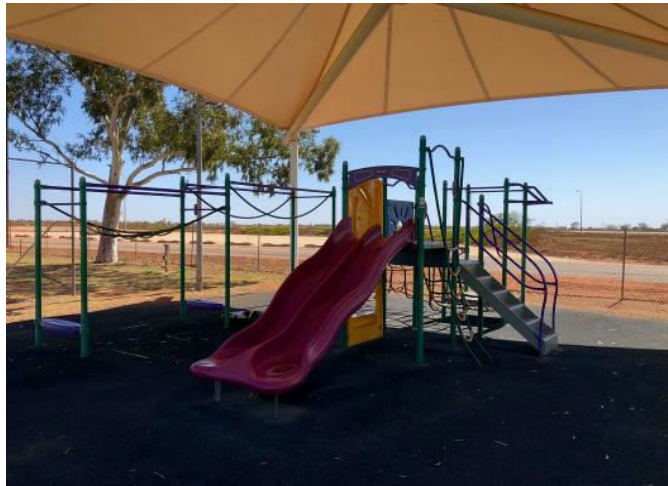
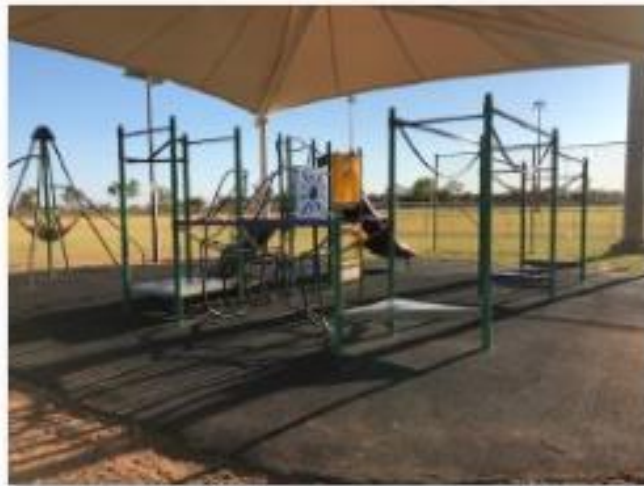
3.

- Super dual slide (1500mm)
- Pygmy Climber
- Mural wall & Binoculars
- Roto wave Panel
- Moulded shop front
- Waterfall Climber (MISSING)
- Stairs (1200mm)
- Square Platforms X 3 (1200, 1400 & 1500mm)
- Tri platform
- Flexi Transfer Climber
- Tube ring X 2
- Chimp twist Senior Primary (MISSING)
- Cave Bridge
- Twist & Turn (MISSING)
- Pause & Recovery Step X 2
