I am proud to present to the community the Town of Port Hedland's Active Transport Strategy 2023 (The Strategy).

# **2.0** Objective A: Connected Network

### Appendix 3: PAW Assessment Sheets

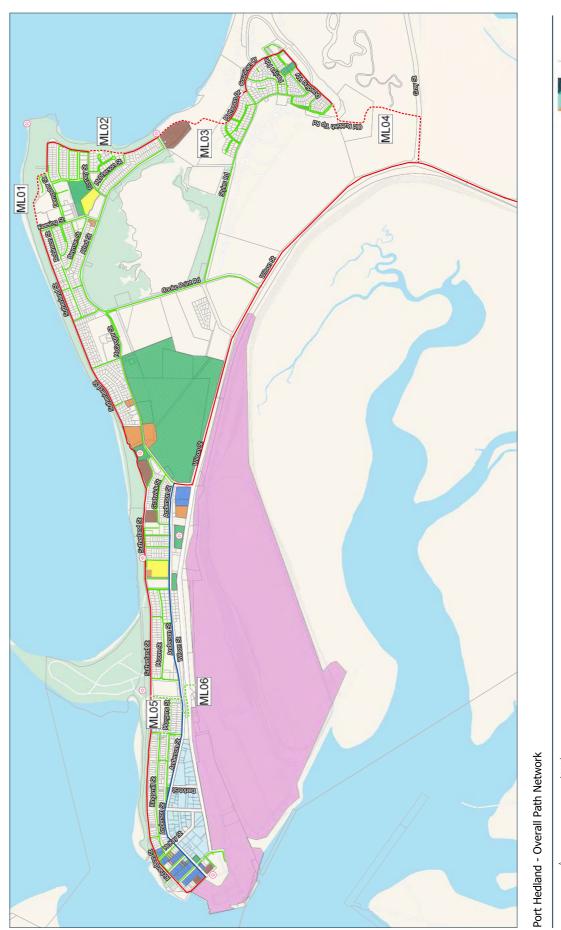
#### Overview Map 1 Port Hedland – Overall Path Network

The Town of Port Hedland's current network has gaps that limit connectivity for pedestrians and bike riders. Residents report that some sections of footpaths and cycle routes are missing and that connections are often poor. This can be a disincentive to walking and cycling and can present barriers for people with limited and restricted mobility. The Department of Transport *Pilbara 2050 Cycling Strategy (2021)* indicates the missing links in Port and South Hedland identified through extensive community consultation. Many of the missing links are between key destinations and precinct areas within the Town. Implementing footpaths in these missing links will also improve access to public transport and other activity intense areas. The Missing Links priority list can be found in Part 2.9 and illustrated on Overall Path Network maps on page 27.

The table below identifies the missing links that are strategic priorities for the Town over the next ten years. They are also illustrated on Overall Path Network maps.

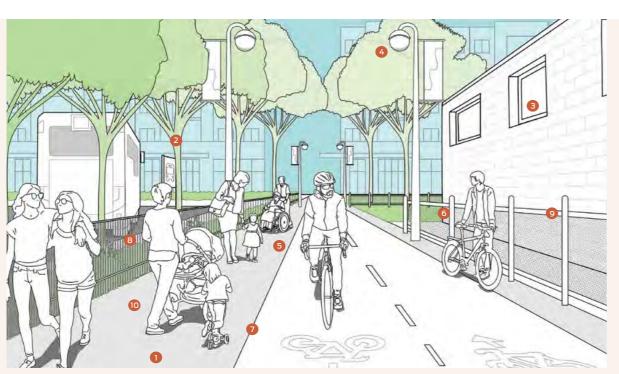
Pedestrian and cycling networks – from Safer Places by Design: CPTED Guidelines and Reducing Crime and Anti-Social Behaviour (2021)

The draft Safer Places by Design CPTED Guidelines and Reducing Crime and Anti-Social Behaviour (2021) provides guidance for the implementation of CPTED principles in a range of scenarios including pedestrian and cycling networks and PAWs.

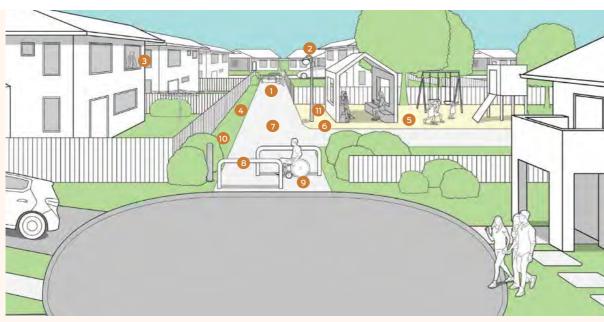
Pedestrian access way – from Safer Places by Design: CPTED Guidelines and Reducing Crime and Anti-Social Behaviour (2021)

Along with this document, the draft Safer Places by Design CPTED Guidelines and Reducing Crime and Anti-Social Behaviour (2021) provides design guidance for PAWs and should be reviewed during the Detailed Design phase of all PAW upgrades, with a CPTED checklist being found in Appendix 2.

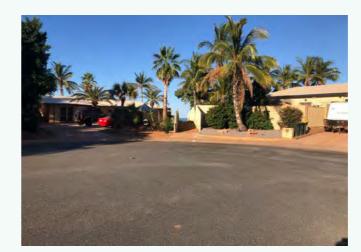
Rawlings Close frontage

Additional comments:	This PAW is not recognised as a coastal access point in the Coastal Foreshore Management Plan.
Classification:	Essential

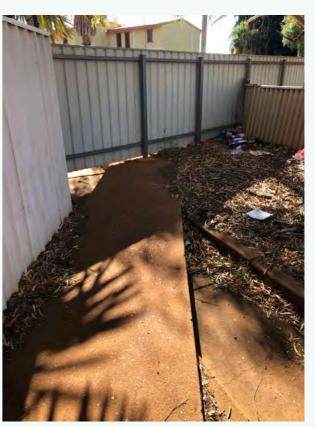
North eastern view from Edkins Place

Locality:	Walnut Grove
PAW Code and Map Reference	Map 3 and WG10
Location:	Mauger Place
Legal Status:	Vacant Crown Land
Native Title Determination Outcome	Native title does not exist
Size:	174m²
Design Characteristics:	Dead end between two residences
Pathways:	Nil
Condition:	Poor, overgrown vegetation and weeds No graffiti or litter
Landscaping/vegetation:	Overgrown vegetation and weeds Not landscaped
Level of casual surveillance:	Visible from Mauger Street
Lighting:	Nil, street lighting on Mauger
Level and type of usage:	Nil, dead end, so serves no connectivity
Presence of infrastructure services:	Telstra footway access chamber and cable Easements to Water Corporation, Horizon Power and Telstra
Utility provider consultation	Water Corporation advised if the PAW were to be closed, the easement retained, the portion containing its infrastructure will need to be rezoned to public purpose reserve vested with the local authority or the asset relocated subject to further consultation.  Horizon advised that there is no cable on this lot. Telstra object subject to discussion with Network Integrity whether an easement or relocation will suffice

WG10	N	NE	Closure is recommended as the PAW is a dead end.

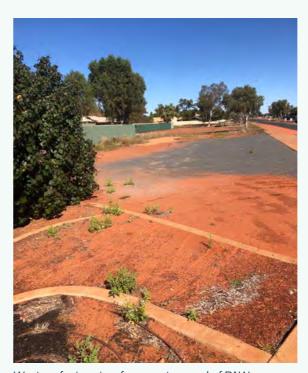
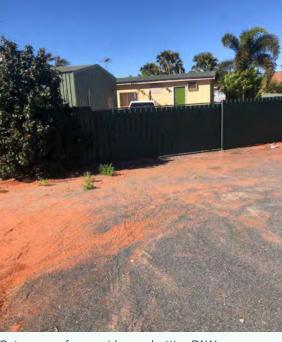
Locality:	Shellborough
PAW Code and Map Reference	Map 5 and SB07
Location:	Runs parallel between Cottier Road reserve and residence on Baler Close
Legal Status:	Vacant Crown Land
Native Title Determination Outcome	Native title exists – non-exclusive
Size:	451m²
Design Characteristics:	Nil
Pathways:	Nil
Condition:	Fair No graffiti on fencing and limited litter.
Landscaping/vegetation:	Marginally overgrown vegetation and weeds, but mostly tidy condition Not landscaped
Level of casual surveillance:	From Cottier Drive
Lighting:	Street lighting on Cottier Drive
Level and type of usage:	Nil as does not provide connection point in addition to the existing footpath on road reserve to the north.
Presence of infrastructure services:	Nil
Utility provider consultation	No comments provided
Community comment/ submissions received:	No submissions received
Additional comments:	Nil
Classification:	Non-essential

Gate access from residence abutting PAW

SB07	N	NE	Closure is recommended.	
SB08	N	NE	Closure is recommended.

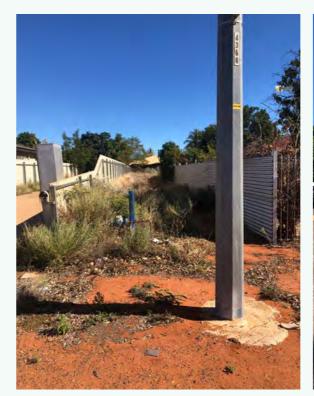
Additional comments:	Nil
Classification:	Non-essential

View from Steamer Ave
